July 7, 2023

RE: 8505 State Bridge Road  
Tree Assessment

A Level II tree assessment was conducted on a 50" Diameter at Breast Height (DBH) Water Oak tree located at the above referenced location. The purpose of the assessment was to determine the current condition of the tree. The observations are as follows:

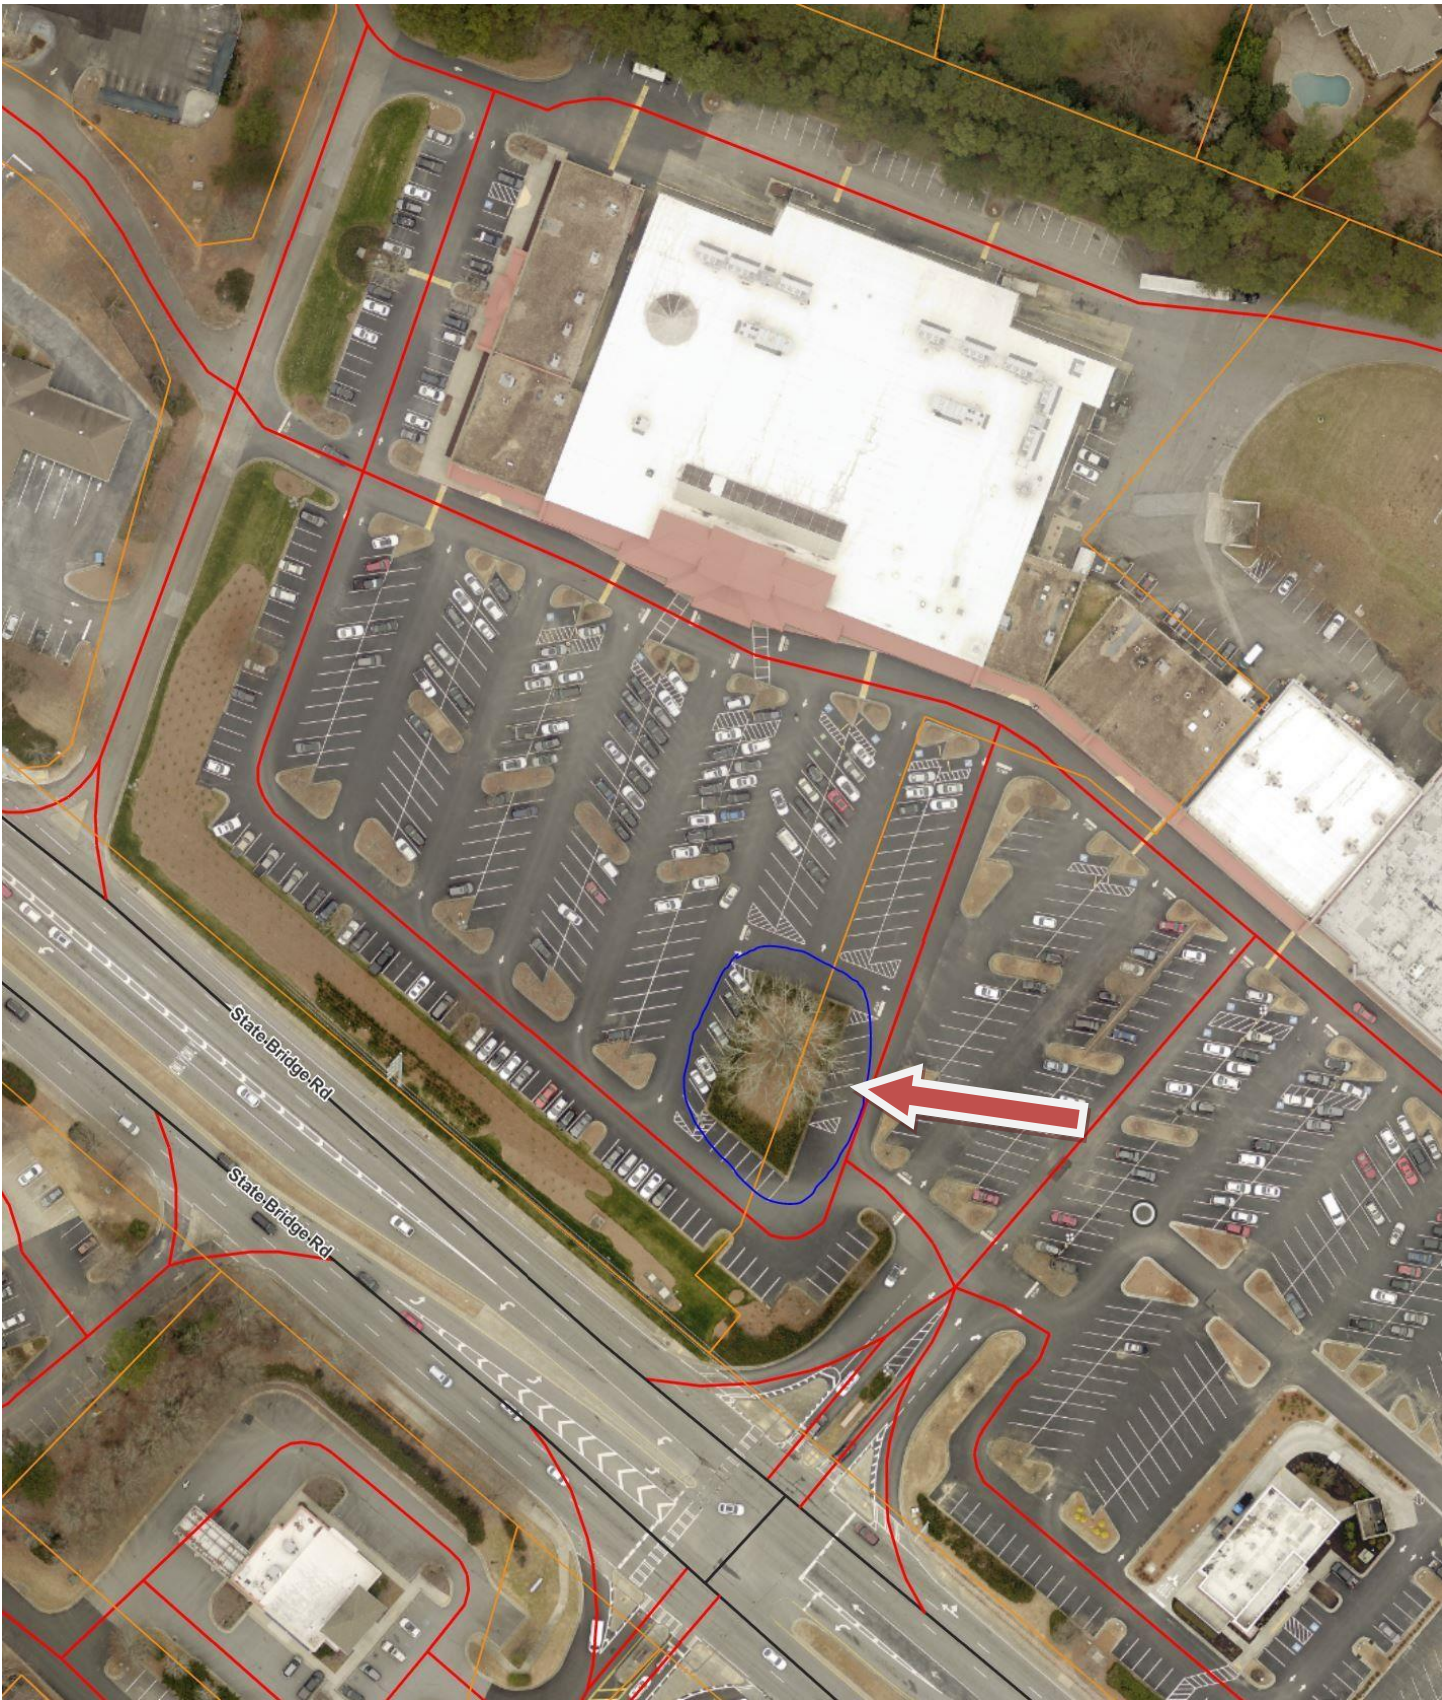
Location of assessed 50" Water Oak tree

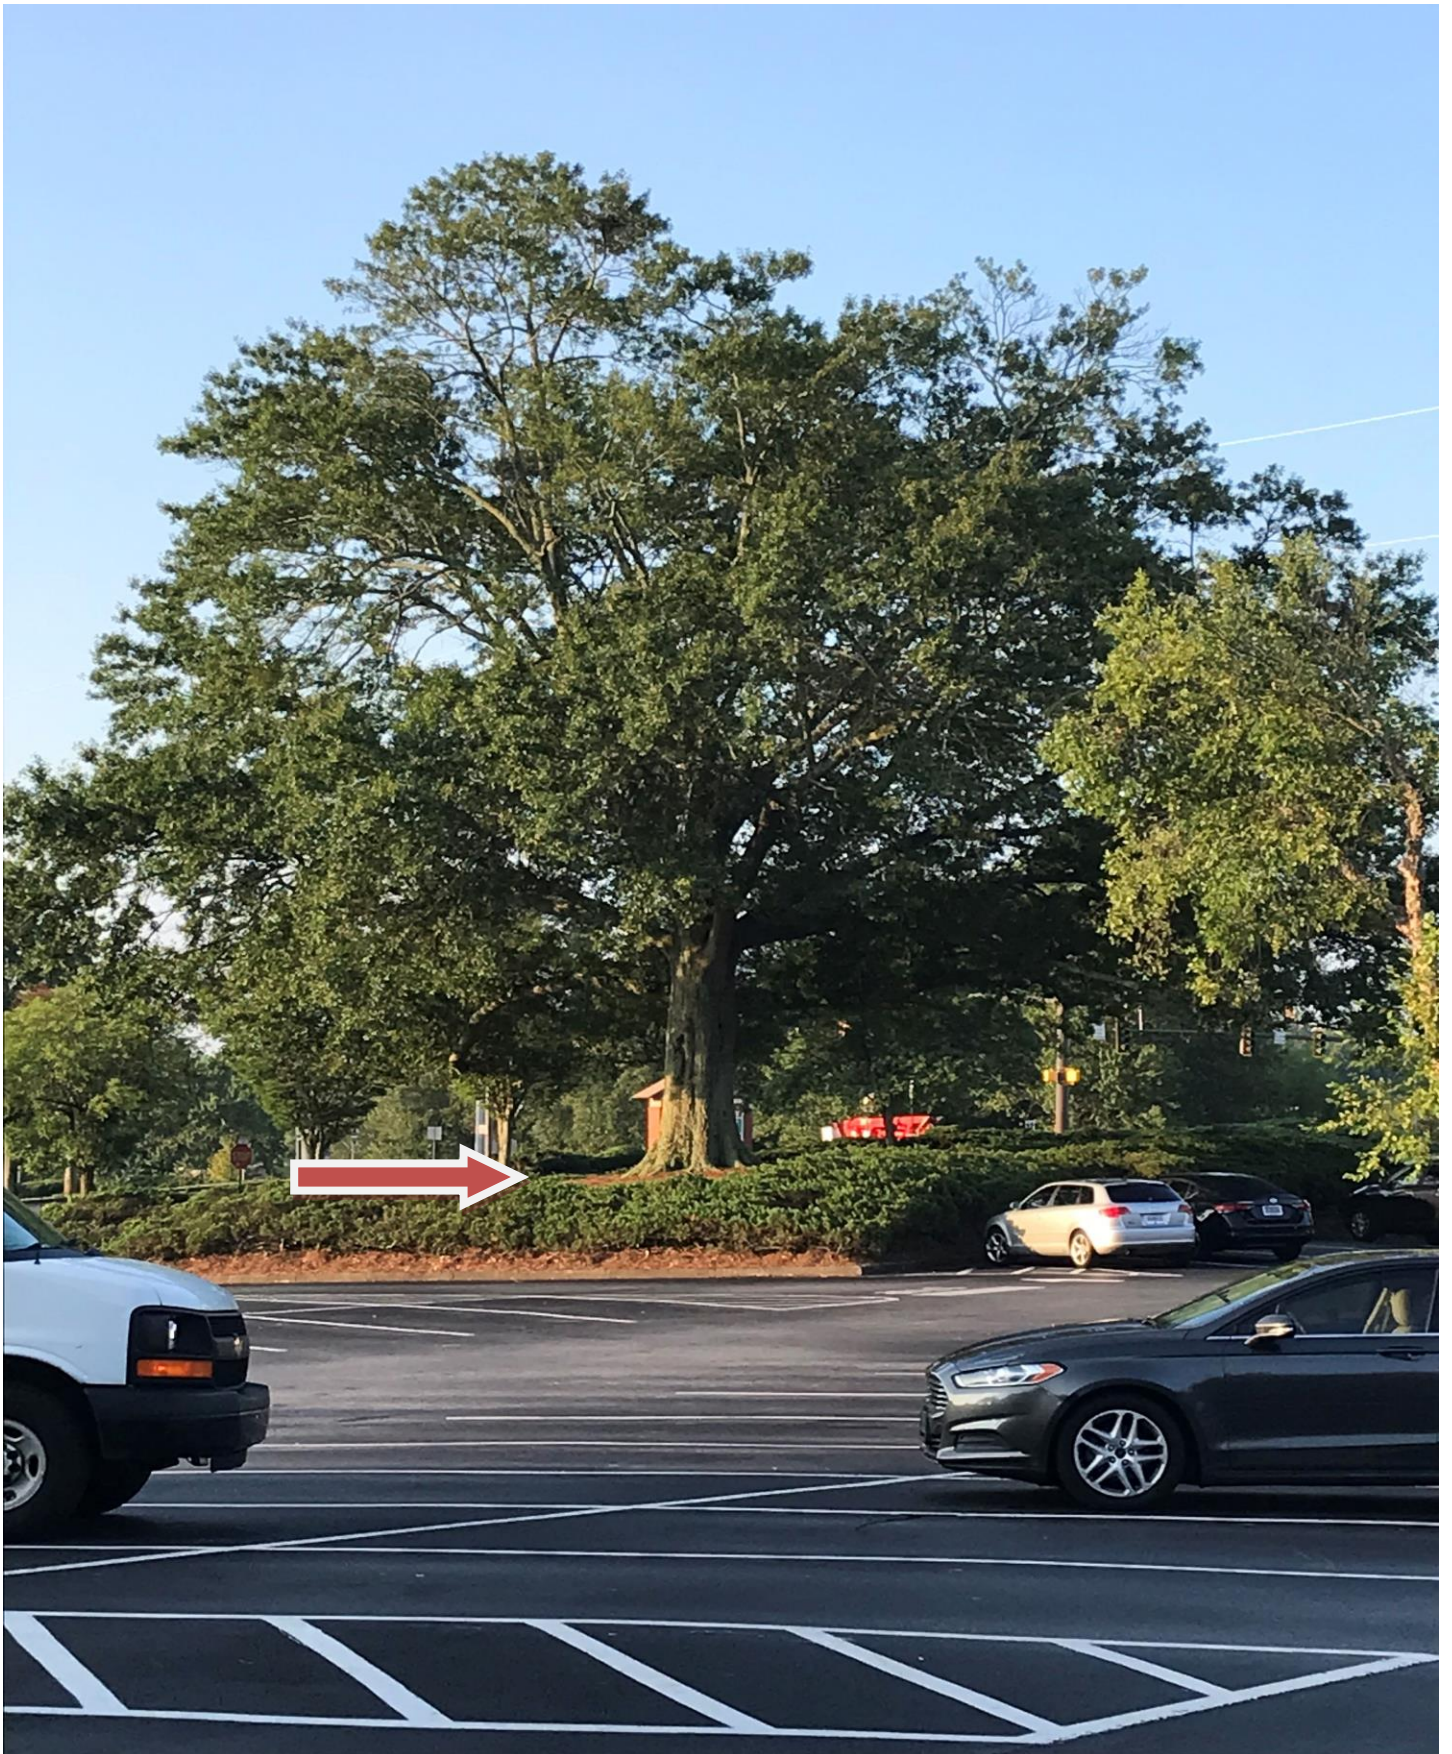
- The tree is located in an island that is elevated approximately 5' from the grade of an existing parking lot
- There is sufficient soil volume to support the root system of the tree

Landscape position of tree

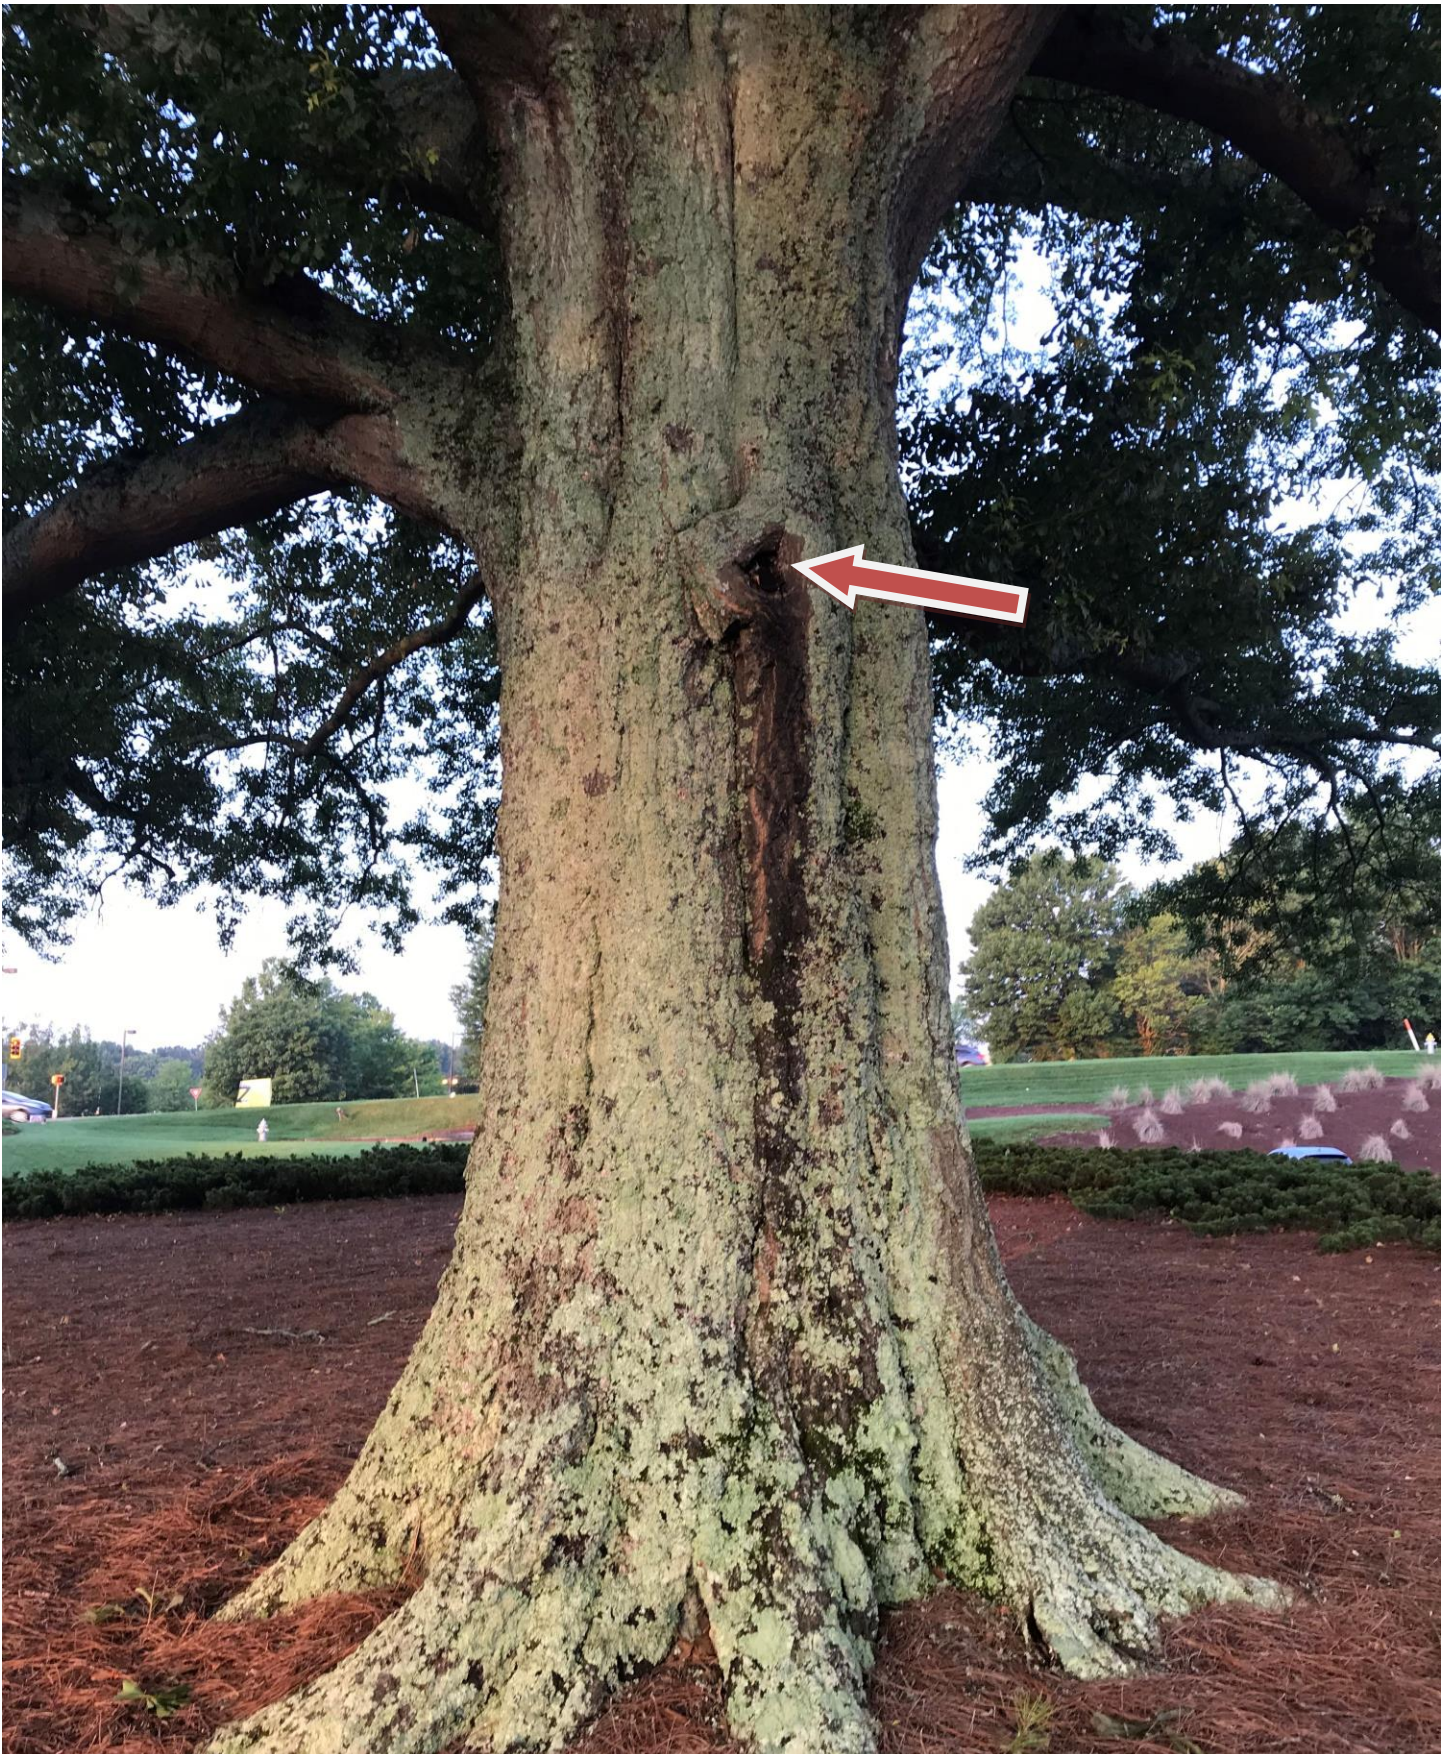
- There is one small old pruning wound on the northeast side of the tree at approximately 10' that has been weeping fluid
- There are multiple low overextended limbs with weak stem attachments

Location of bleeding wound

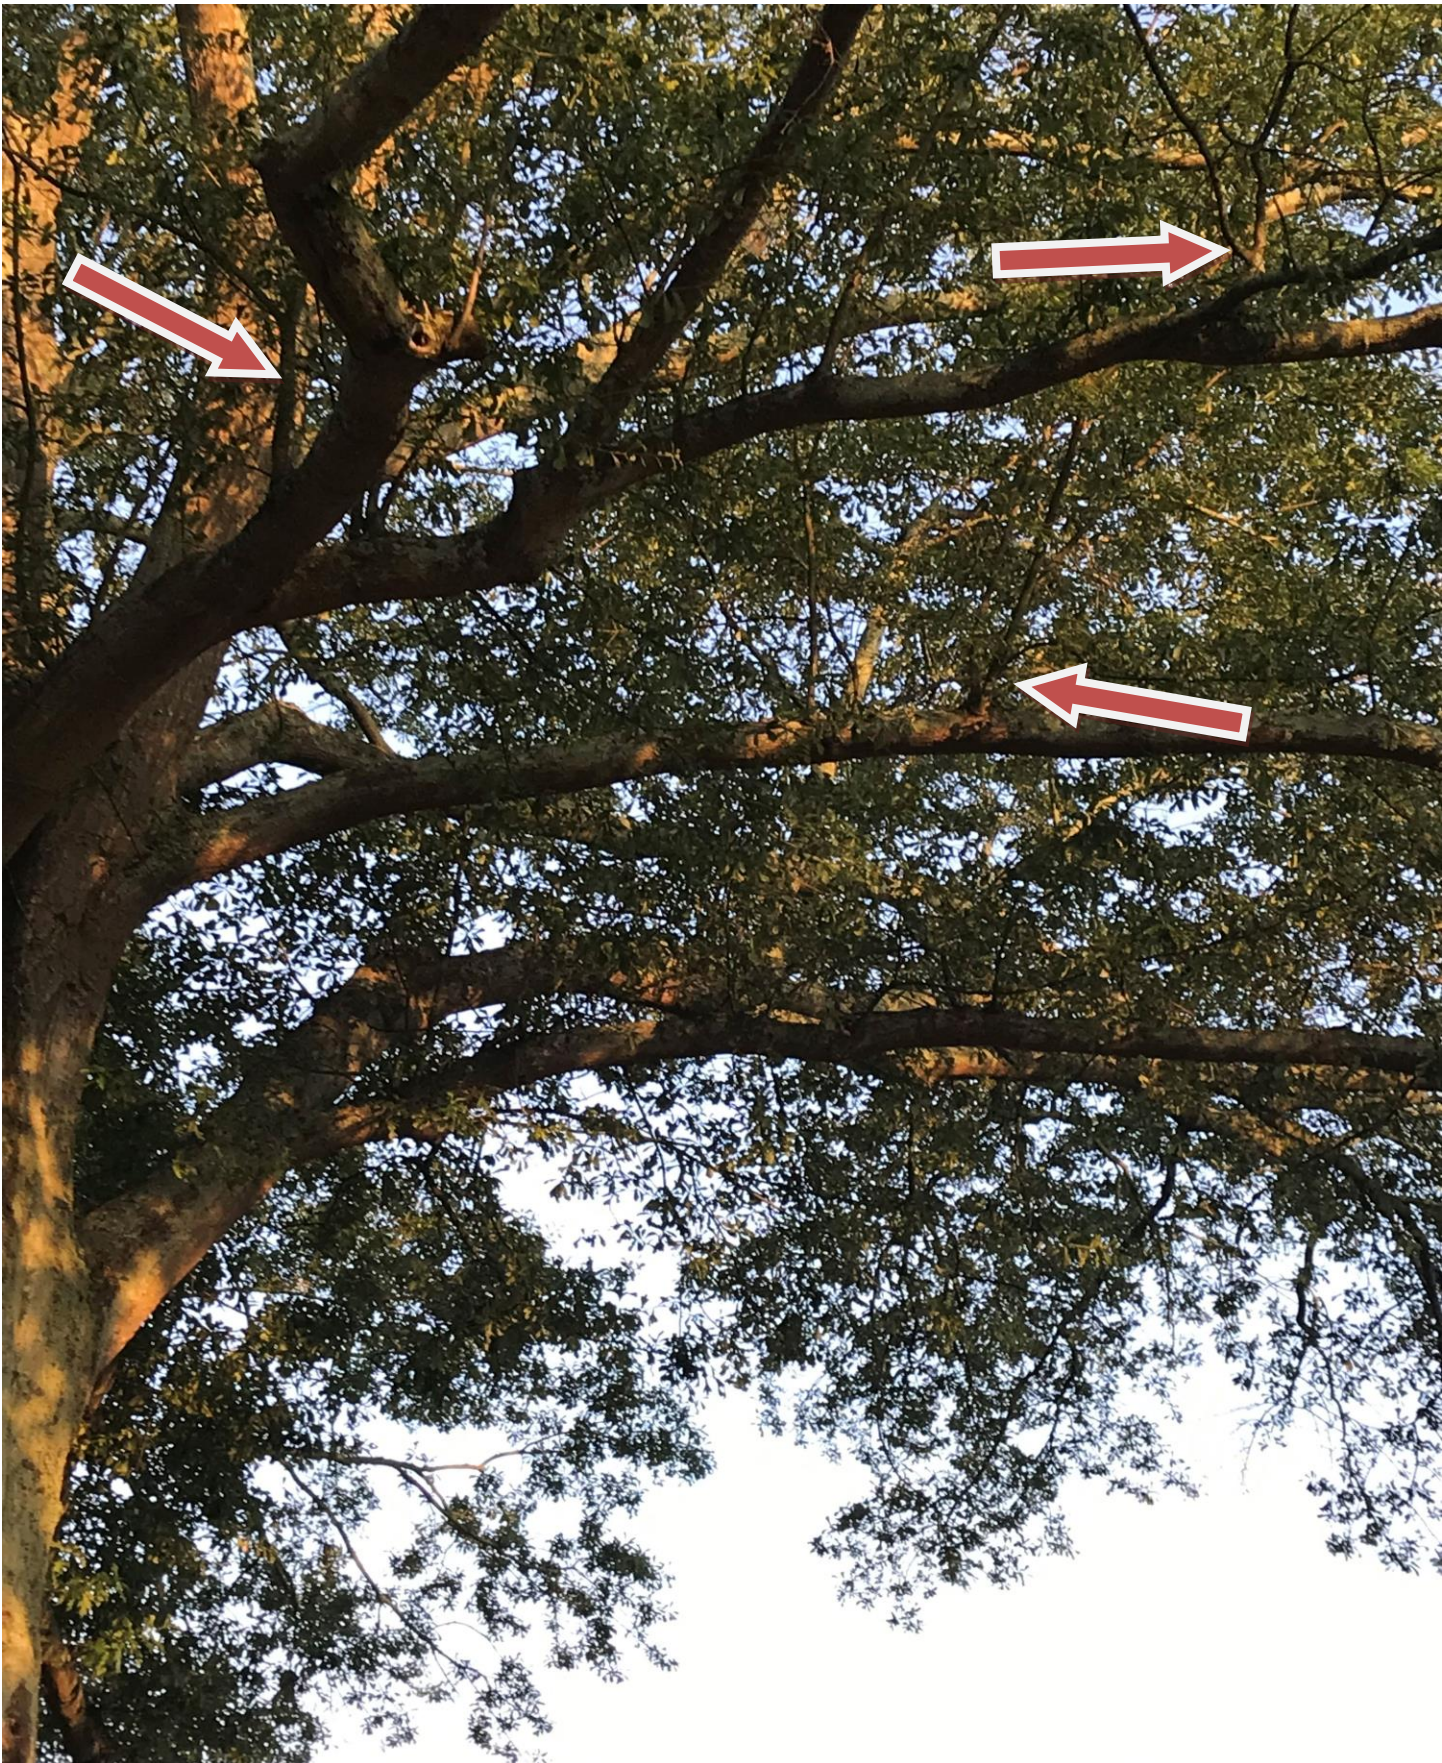
The numerous epicormic sprouts (vertical small branches emanating from main tree branches) are an indicator that the tree is experiencing some type of stress often seen in trees during the initial stages of decline.

Examples of significant epicormic sprouting  
8505 State Bridge Road Tree Assessment by Arborguard, 7/7/2023

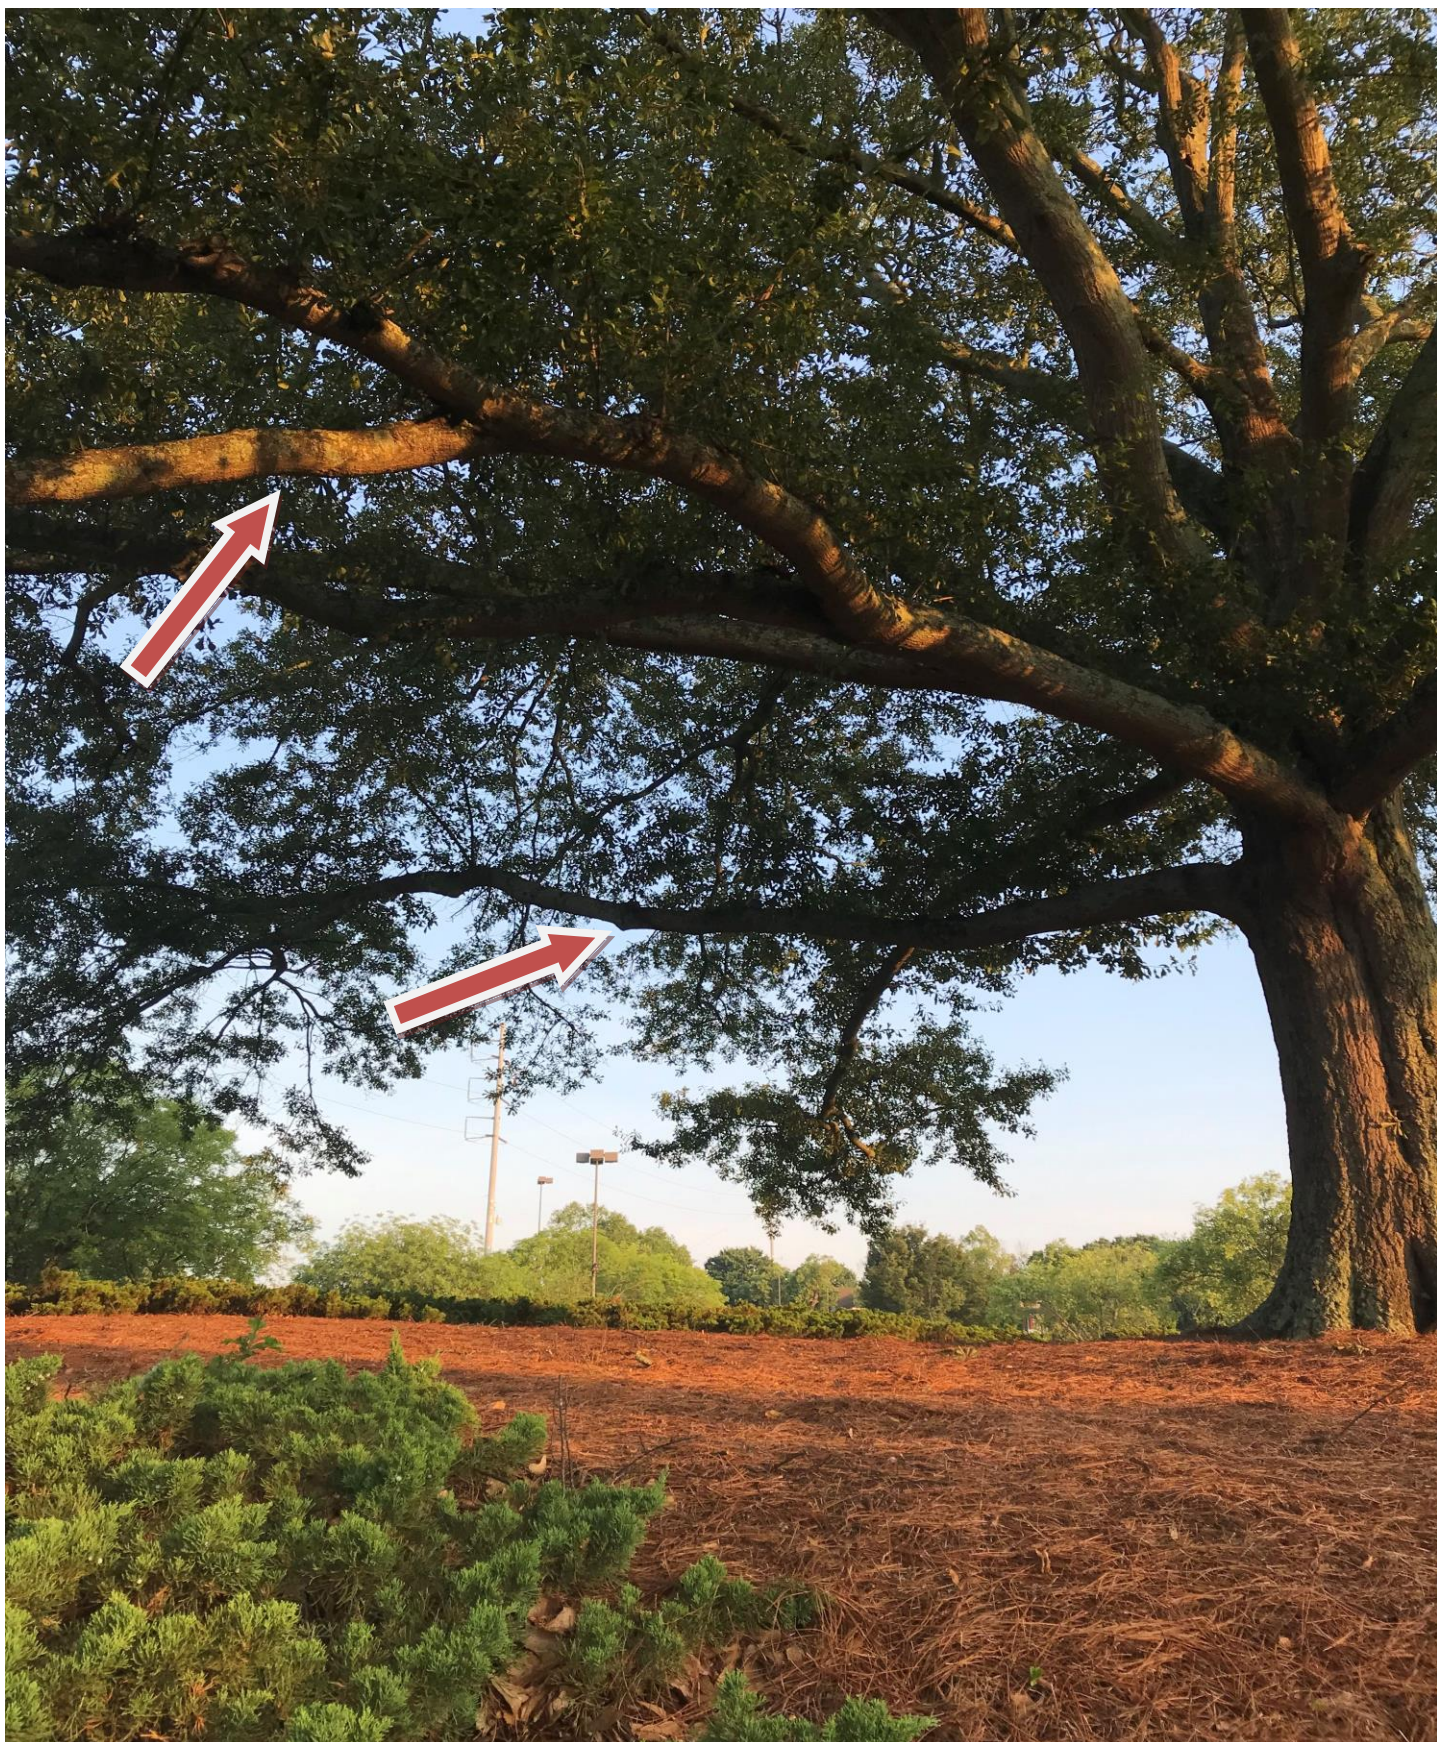
There are multiple low limbs that are overextended and are bearing a significant amount of foliar end weight. The typical failure mechanism of a mature hardwood tree is to start shedding these large, overextended limbs. The process is called retrenchment and is a common survival strategy intended to prolong its life.

Examples of overextended limbs

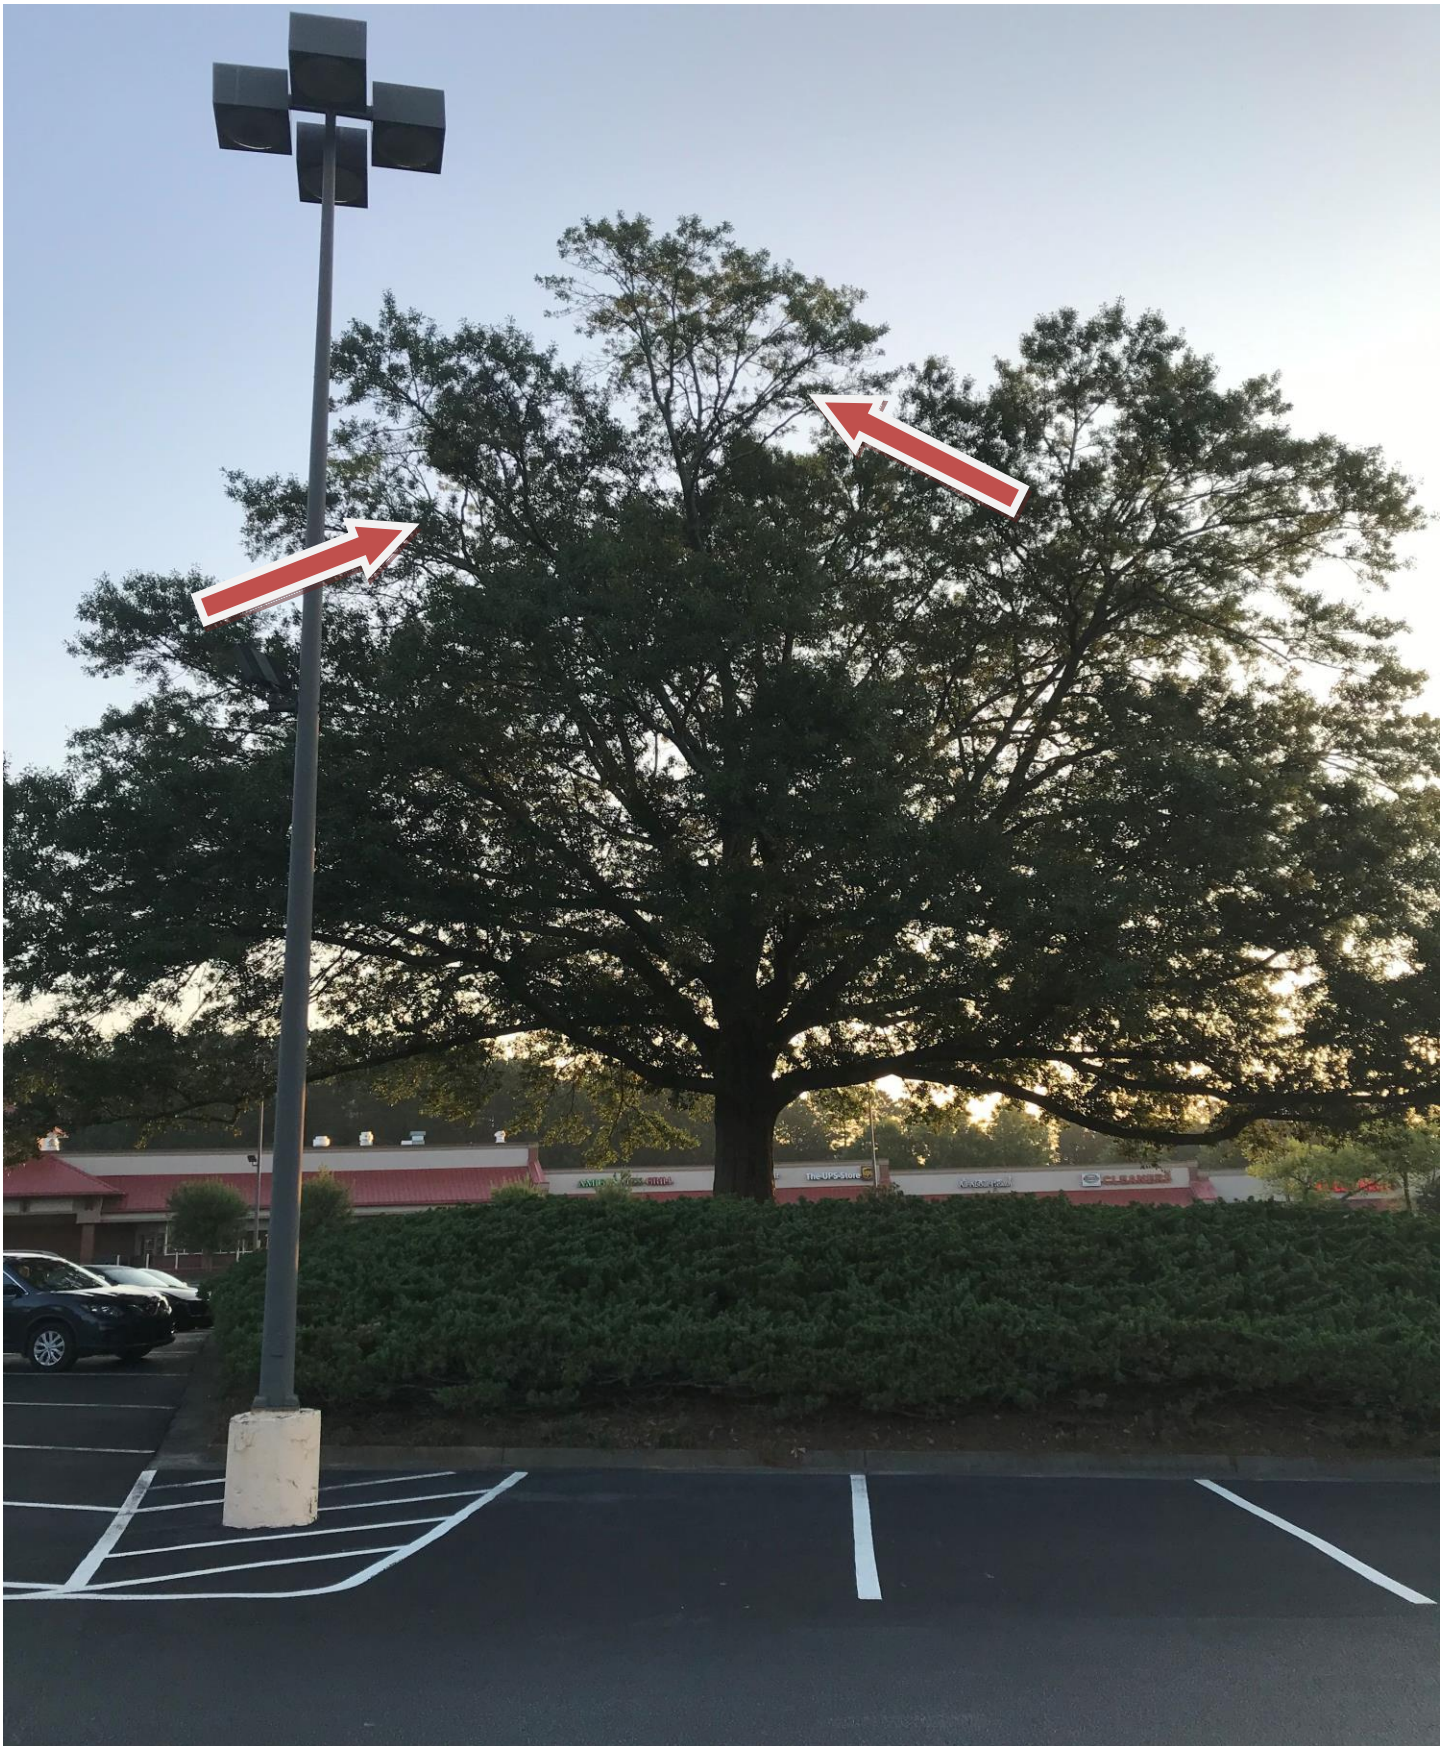
This tree is currently exhibiting signs of decline in the upper canopy signified by two areas of obvious decline located on the northeast and southwest sides of the tree and a general slight thinning of foliage in the upper canopy. The lower portions of the tree canopy appear to be healthy.

General thinning of the upper canopy

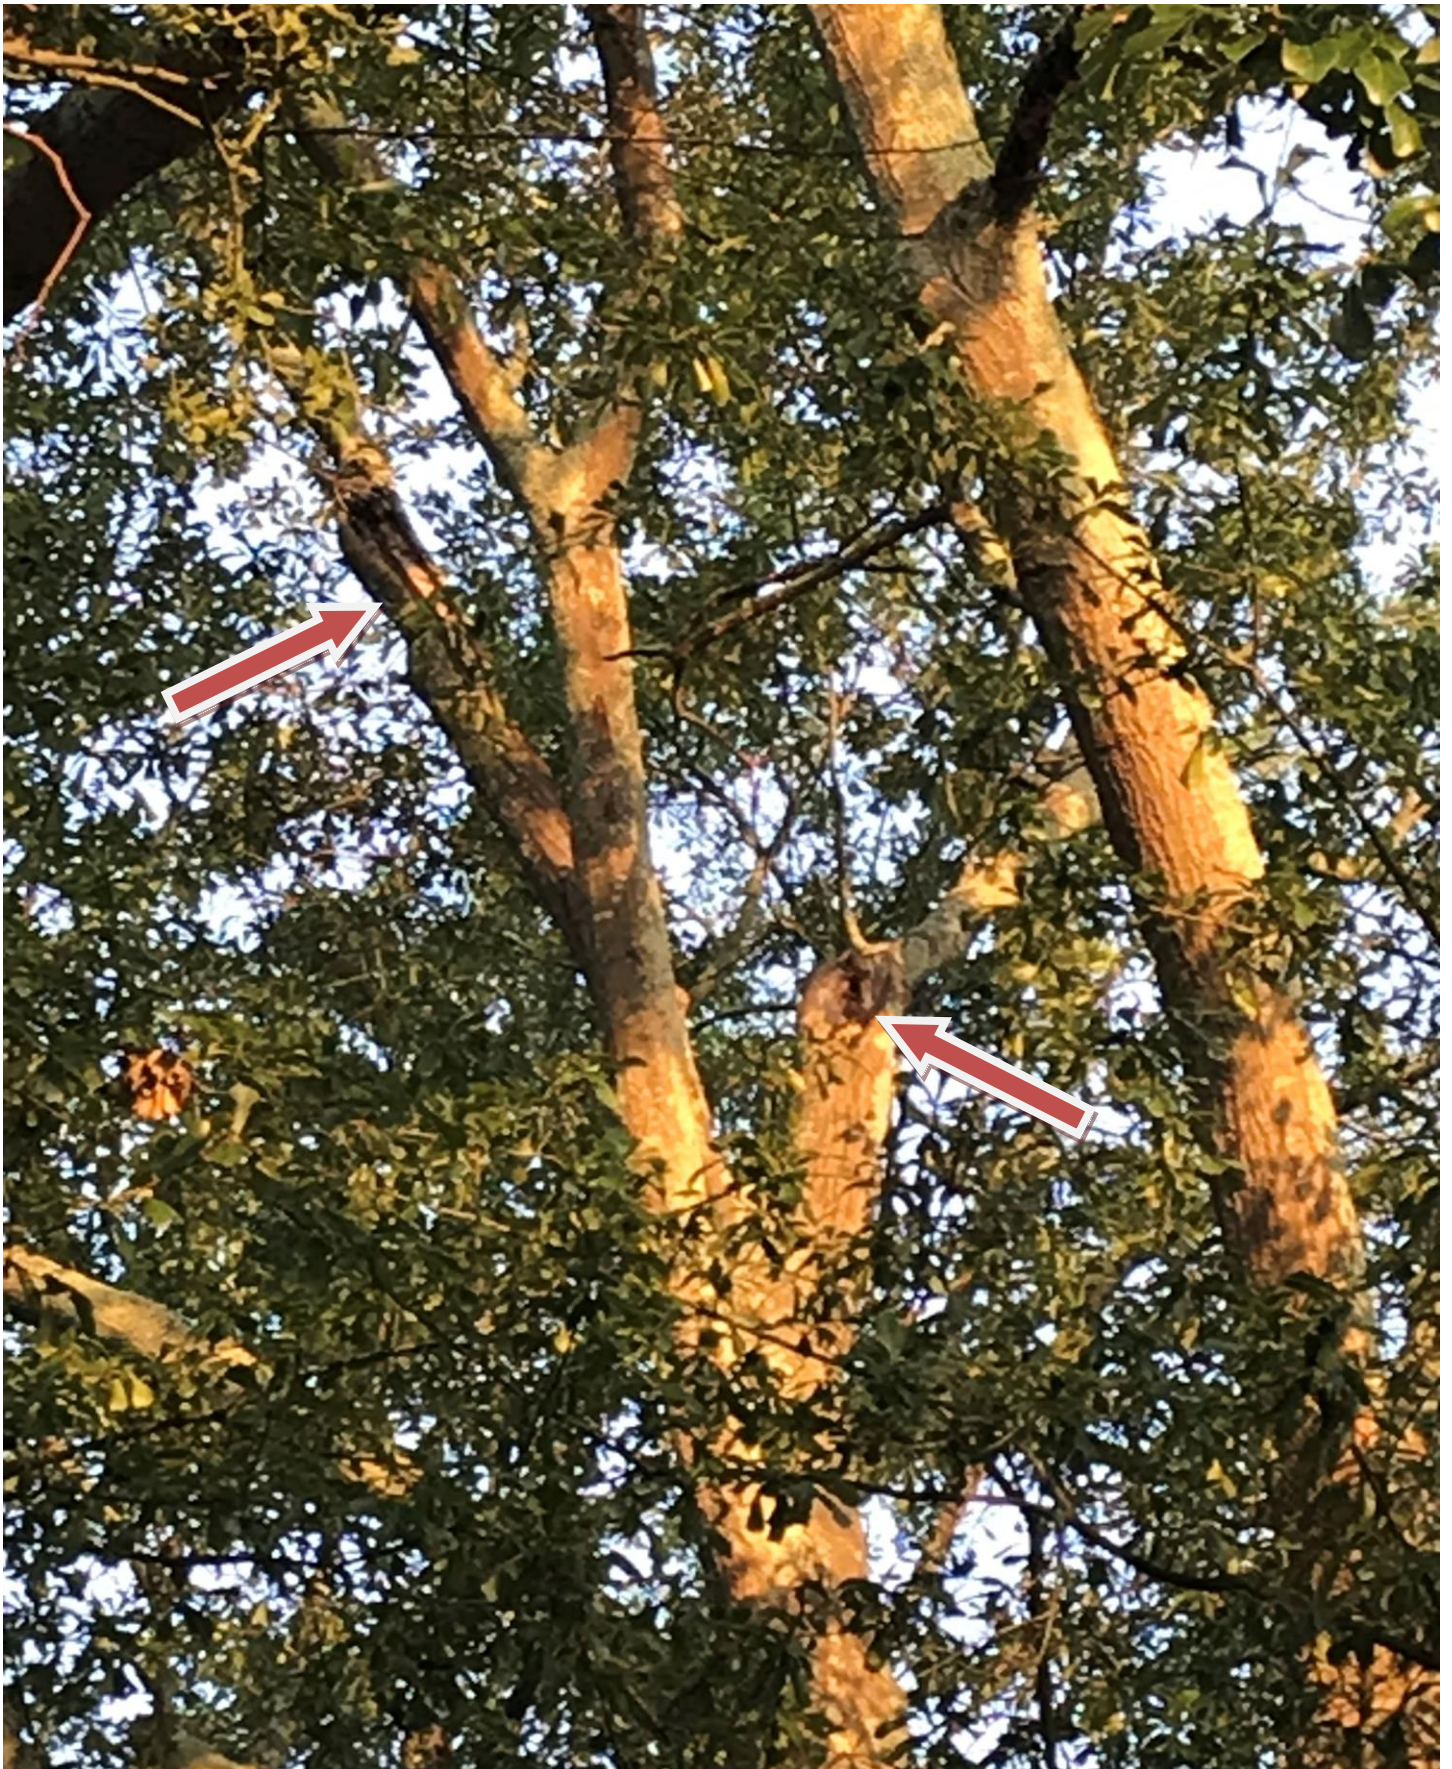
There are two stems in the upper tree canopy that have obvious areas of decay, these stems will likely fail at some point within the next couple of years.

Two stems in upper canopy with decay  
8505 State Bridge Road Tree Assessment by Arborguard, 7/7/2023
